RT130 3.4.3 Firmware Update - PASSCAL User Notes

Eric Makarewicz and Brit O'Neill, 2013-05-07

In this document are listed the firmware changes between version 3.0.0 and 3.4.3, from the Reftek 130-CPU Firmware Release Notes, along with comments on how usage or results are different for some of the changes.

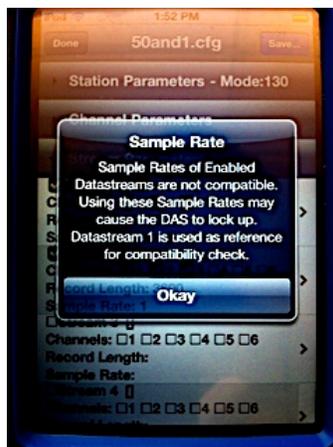
If you try to program a PASSCAL RT-130 for this option (i.e. using 50 sps with another sample rate) using iFSC in the 130 mode, it will either not allow you to chose mismatched data streams or it will give an error like this:

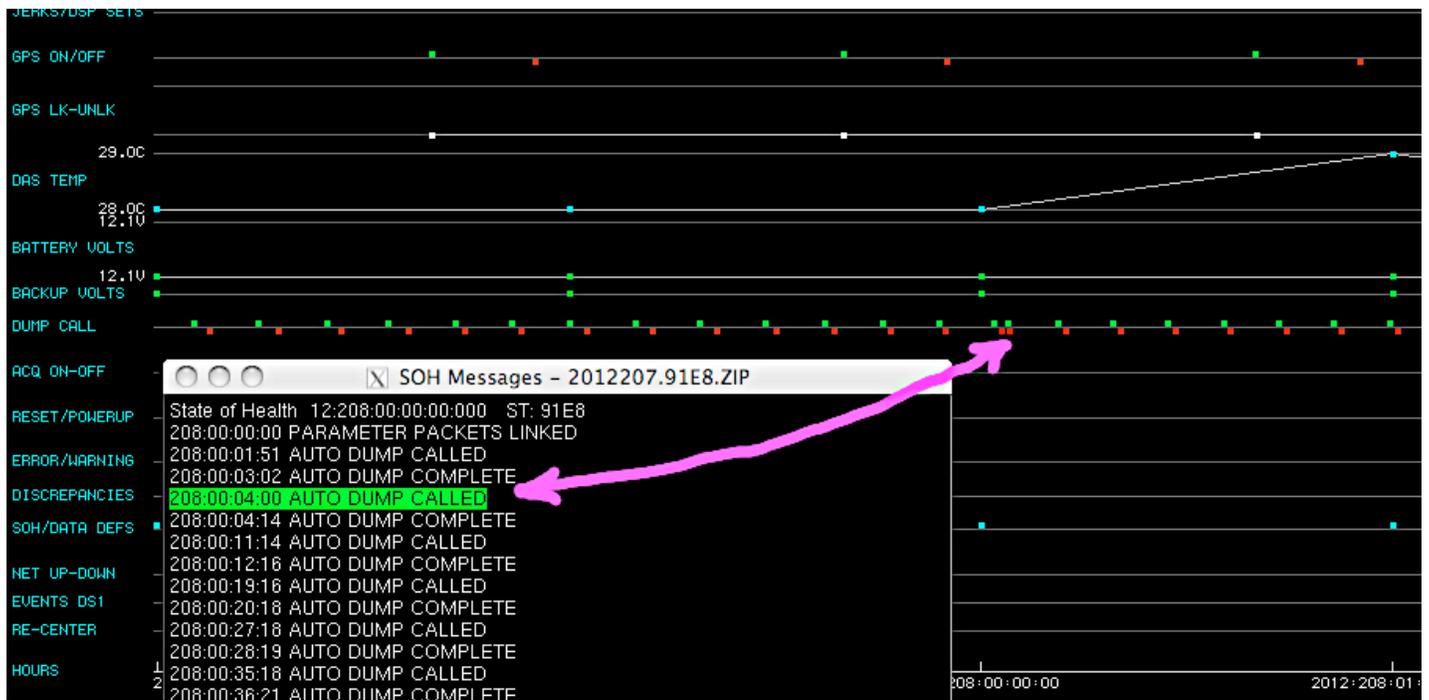
Using normal PASSCAL disk setup (dump threshold at 66%, auto-wrap off, dump on ET off), with the 3.0.0 firmware the dumps to disk are done when RAM reaches 66%. However, with the 3.4.3 firmware there is an additional dump to disk done at 12:04 AM each night, even if a RAM dump occurred recently. This additional dump to disk is noticeable in the log and in logpeek, as highlighted with arrows in the figure below:

Additional daily dump to disk at 12:04 AM

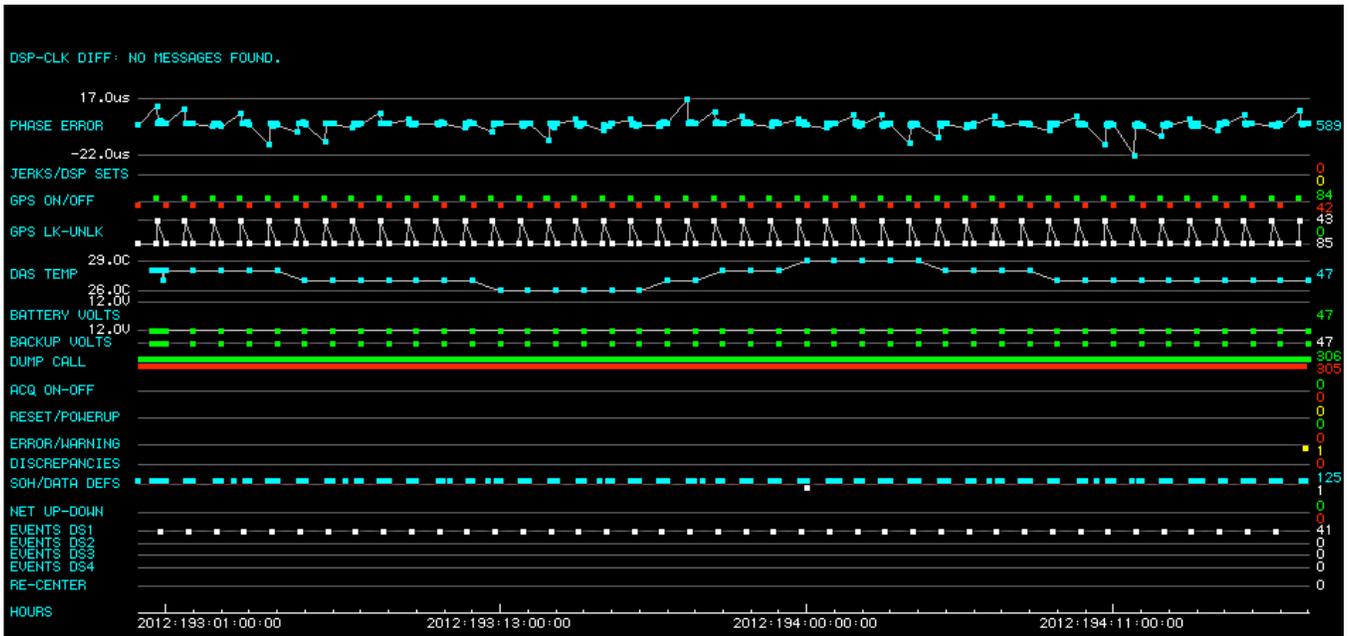
The difference in the Phase Error message output is seen dramatically in logpeek. The first logpeek screen

below is from 3.0.0FW while the second screen capture is from a DAS with 3.4.3FW. Note the significantly different pattern in the phase error traces:

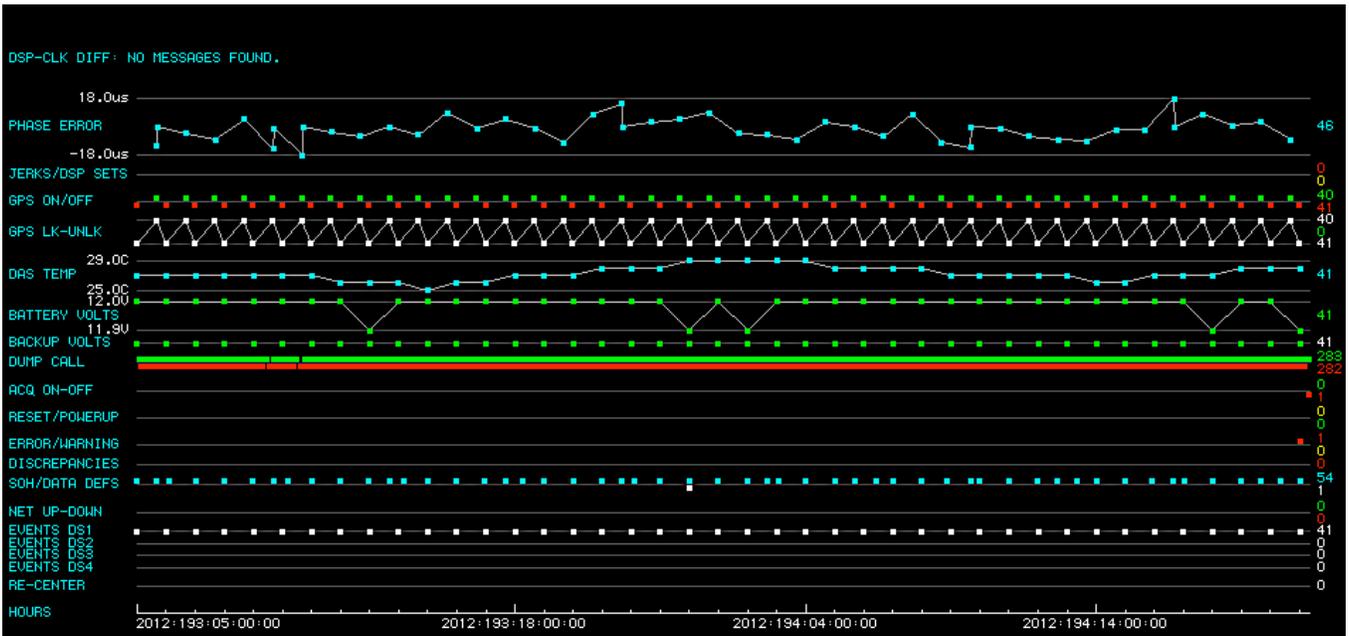
3.4.3FW

Another point of interest that is illustrated in the two logpeek screen captures above is the additional difference in the GPS LK-UNLK traces. The difference can be seen in the SOH log text examples above as well. In the 3.0.0 example at the start of the clock cycle, the first poll of the clock finds it's status unlocked and then in the second poll 15 seconds later the clock is locked. Finding the clock initially unlocked generates the sawtooth LK-UNLK trace in the upper screen capture. On the 3.4.3 example, the initial poll of the GPS finds it locked,

and this generates the zig-zag LK-UNLK trace in the lower screen. This difference at the start of the clock cycle is not due to DAS firmware. It is due to the receivers in these particular clocks. In both instances the clocks are the older "white-ring" Garmins. However, the receiver clock shown in the lower panel was a 15X-HVS rather than the older 15-HVS. Likewise in the "puck" style of GPS clocks, some are a 16-HVS and some have a 16X-HVS. The "X" versions of receivers lock faster than the older versions. (We've tried to note in inventory which are 15X and 16X.)

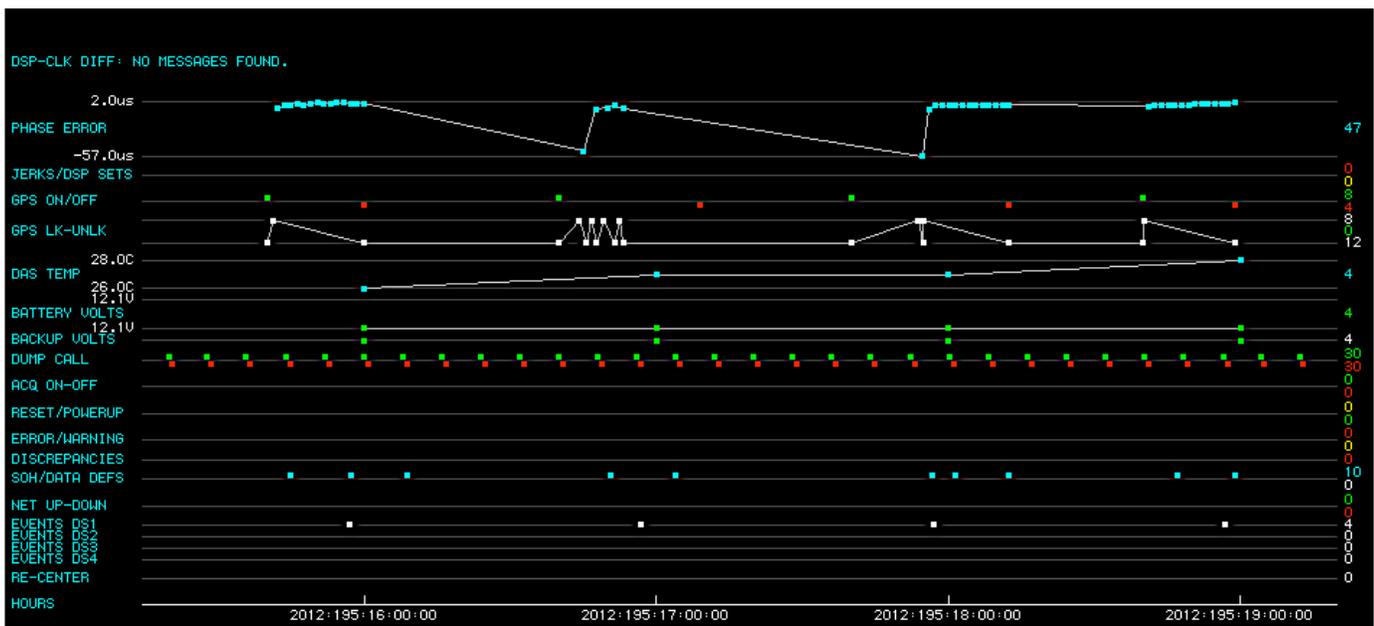
With 3.0.0 firmware, during the GPS power On cycle, when the lock was lost during phase error calculations, larger errors could be calculated. In the logpeek capture below, the lock was lost near the start of two GPS cycles (as seen in the GPS LK-UNLK trace) and >50 μ second errors were calculated (shown in the light blue PHASE ERROR trace). This is also detailed, and highlighted, in the log messages below the screen capture:

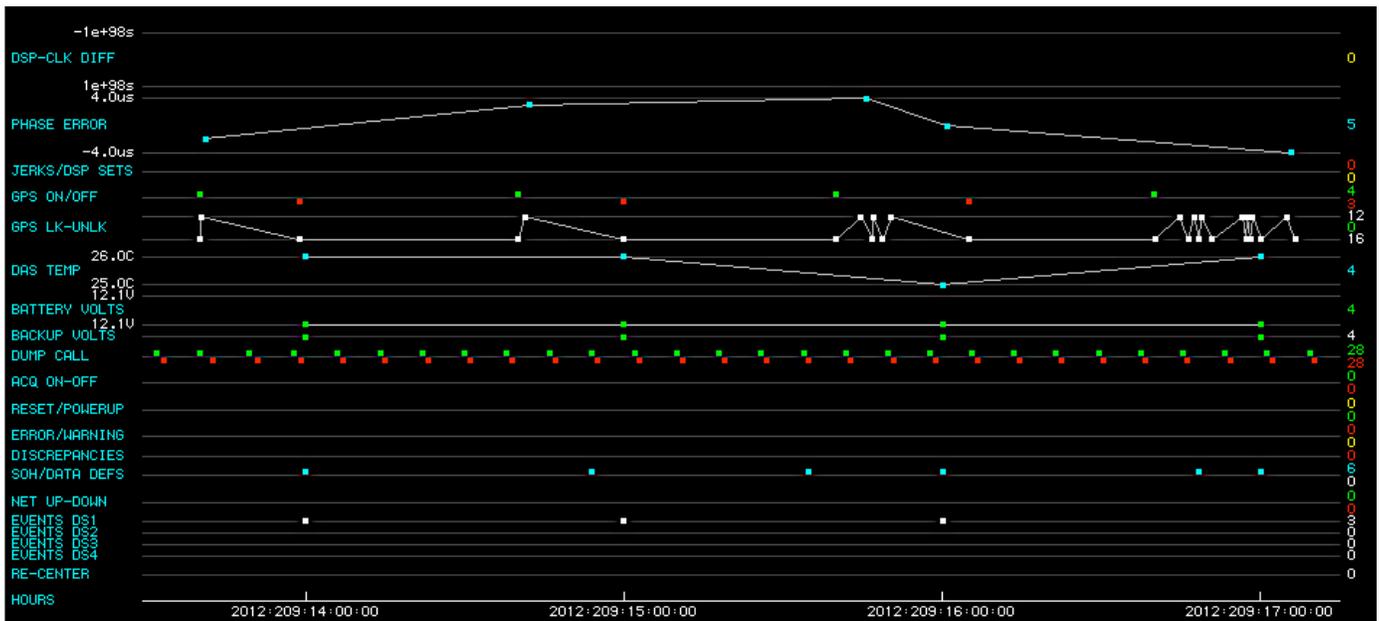
With 3.4.3, when the GPS lock was lost during phase error calculations, drift corrections were suspended. The logpeek screen capture below shows a similar example to that above, of the GPS lock being lost, but the suspension of drift corrections prevents the larger phase errors (the scale on the Phase Error trace is +4.0 to -4.0 μ seconds). The log messages for this example, showing the suspension of drift correction, are listed below the screen capture:
